FEBRUARY, 1955

STRUCTURAL SUCCESS OR FAILURE?

by Jacob Feld, M. ASCE

CONSTRUCTION DIVISION

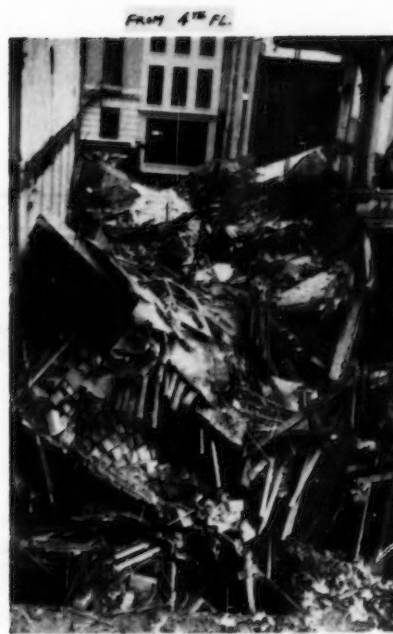
Fig. 2. Funnel of collapse.

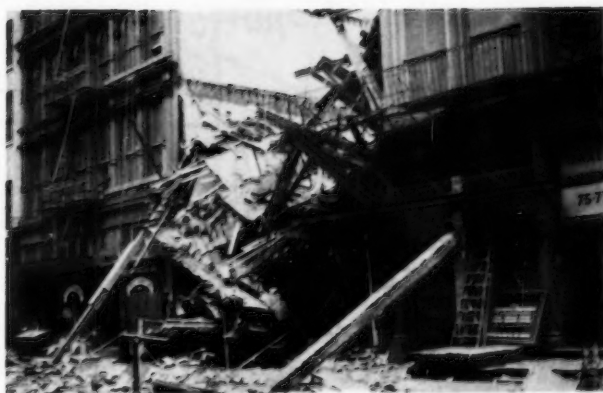
Fig. 3. Funnel of collapse.

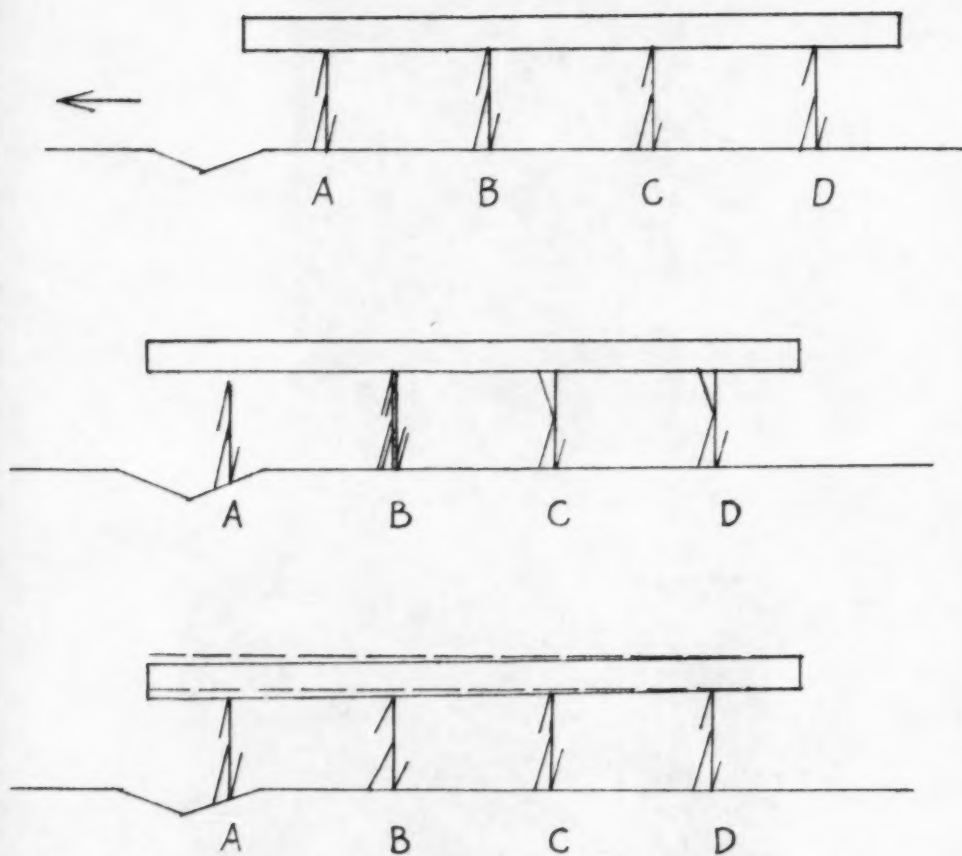
In 1940 at the Purdue University conference on Soil Mechanics, I showed some sketches to explain sudden changes in bracing reactions in trench sheeting. The same explanation is applicable to several types of structural failure where unexpected loads and reactions occur and so it is here repeated. A rigid timber carried by four men who have located themselves so as to support equal loads is being carried along a smooth surface (Fig. 4). When

man A steps into a depression, man B is overloaded and may collapse, throwing load back to A and some additional load to C with possible uplift on D. It is a simple qualitative description of how the reactions of a continuous structure are sensitive to displacement of the supports. It is the explanation of many types of structural failures.

Fig. 4. Load transfer from settlement of support of rigid structure.

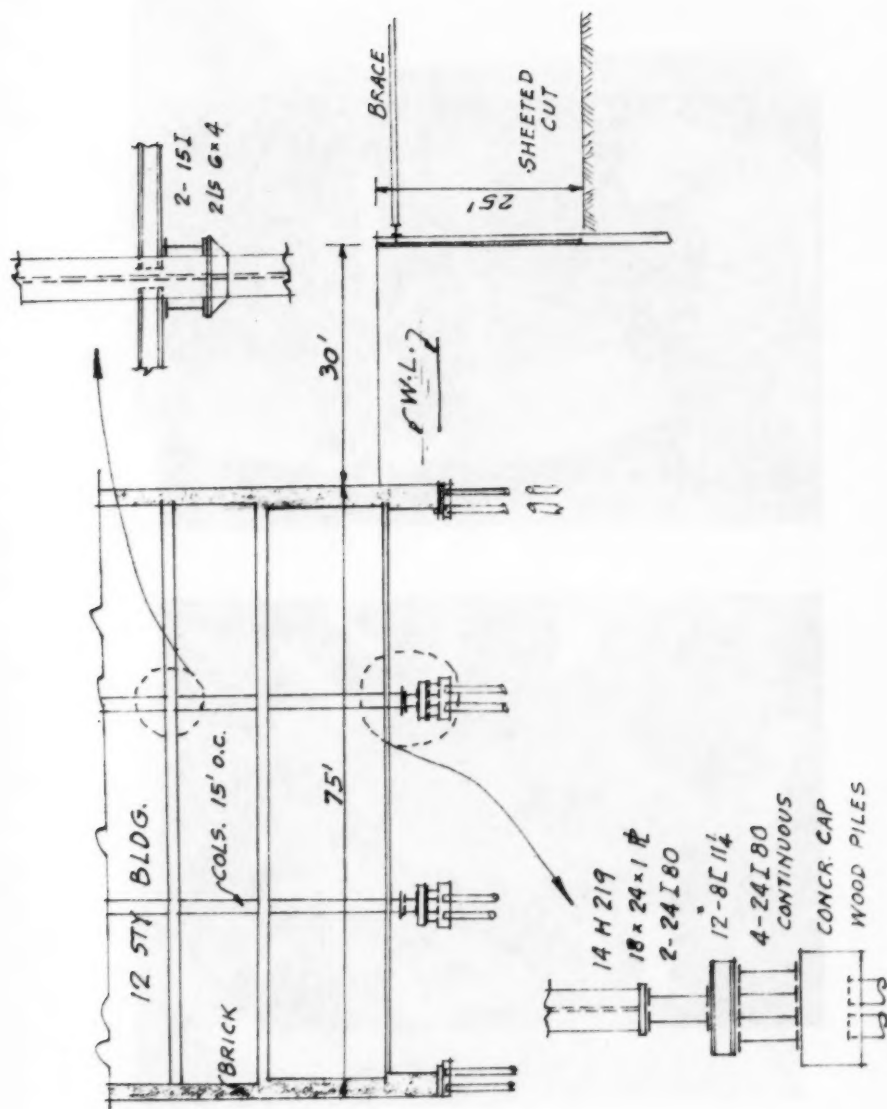
An interesting and successful repair project handled a few years ago was the reconstruction of the structural steel frame of a 12 story office building where two interior columns suddenly dropped some 12 inches at 8 A.M. on a cold Saturday morning. Only the watchman was around and he first noticed that the roof water tank was broken and the water ran through the building washing papers into the street. Inspection of the column bases showed that 24" in beam grillages under two columns had collapsed and squeezed down 12". Careful mathematical analysis of the frame as a continuous structure indicated that the maximum loads which could come to these columns, if all foundations were equally stable—were not enough to overload the columns or the grillages. The materials existing on each floor were measured and weighed to determine actual live load, which was found to average 60 pounds per square foot, far below the rated permissive loading. The only source of load sufficient to crush the grillages was the exterior wall and exposures indicated new movements at foundation level. The section (Fig. 5) shows how neighboring excavation and dewatering caused temporary release of the foundation support under the exterior wall, transfer of the load to the next interior line of supports and collapse from overloading. Fig. 6 The collapse readjusted conditions to force the outside footing to take load again. Reconstruction procedure was rather simple. After shoring the floors at the failure areas, new grillage beams were placed of reduced depth to fit the space between the continuous pile cap and the column base, and each floor was jacked back to level with steel fillers set to close the gaps between the bottom of the floor girders and the column brackets reused as girder supports.

Fig. 5. Section of 12 sty. building with grillage detail.

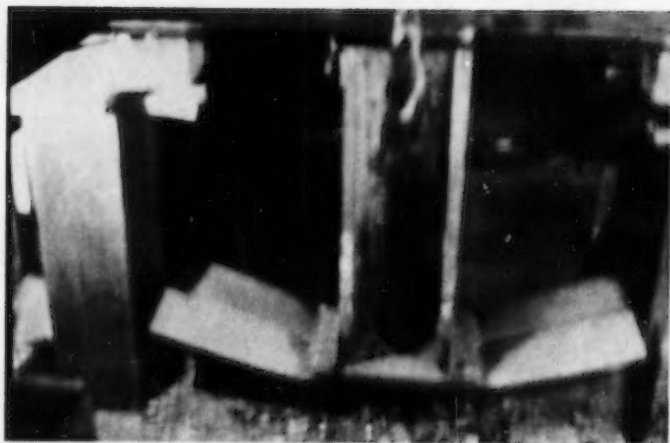
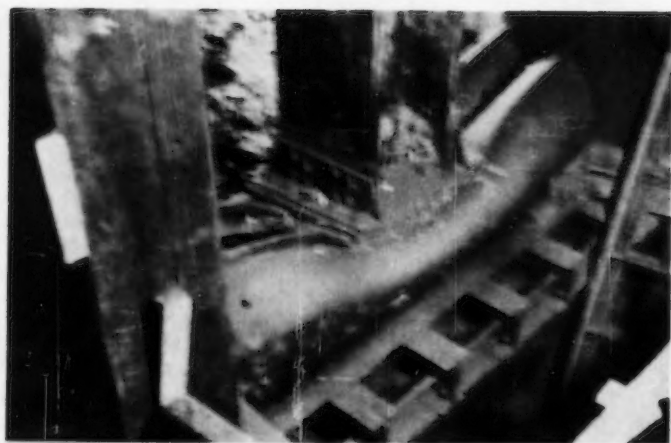
Fig. 6. Collapsed grillages.

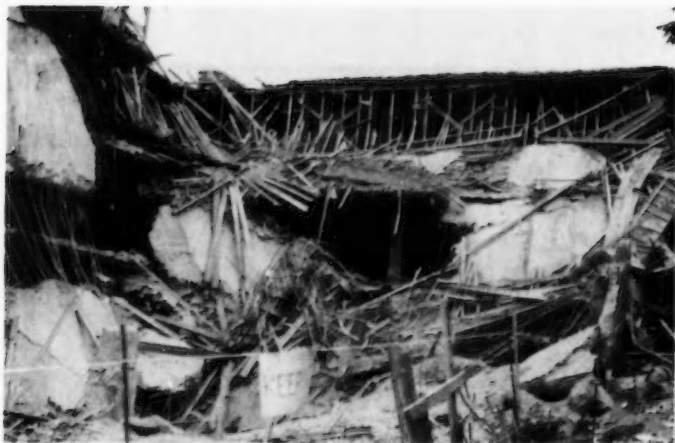
A more recent well publicized collapse of a concrete structure was also diagnosed on the basis of photographs which showed a funnel of failure pointing to an interior column as the axis of first movement. (Figs. 7 and 8) Later investigation showed that this column in the bottom story was tipped toward the exterior wall and the foundation conditions under the exterior wall columns were not the sound rock called for on the design plans. Transfer of load, in this case the weight of the concrete only, caused overstress at foundation level, tipping and loss of support in the flat slab floors. The slab could not span 54 feet, after one support became inoperative, and so collapse resulted. Investigation showed several discrepancies between design assumptions and actual performance, in addition to the foundations, and the structure was almost completely demolished before reconstruction. Lack of control and inspection has cost everyone concerned tremendous sums of money, not to mention the loss of three lives and injury to other workmen.

Fig. 7. Collapsed concrete structure.

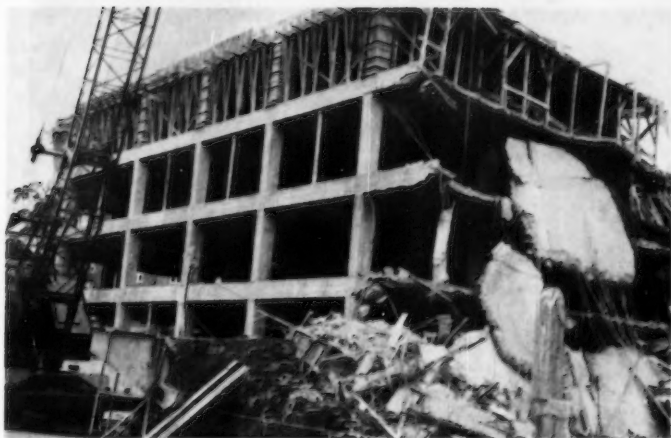
Fig. 8. Limit of collapse.

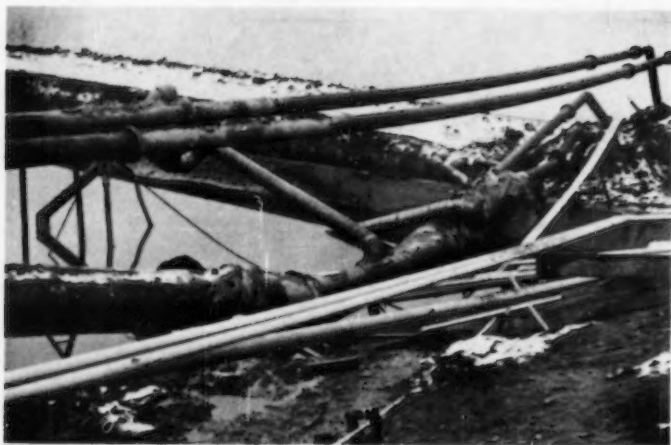
Well known pressures, such as the atmospheric pressure and hydrostatic pressure will cause failure if permitted to act where sufficient resistance is not provided. Steel rectangular tanks for fuel oil storage failed completely during a very cold day, when the evaporation of steam from the heated oil had frozen up the air relief pipes and oil was being withdrawn from storage with no available opening for air replacement. (Fig. 9) Concrete basement walls backfilled with clay which shrinks away from the concrete as it dries, leaves a narrow but continuous gap into which storm water flows easily and imposes full hydrostatic pressure. Figures 10 and 11 show the result of such conditions.

Fig. 9. Collapsed steel tank by air pressure.

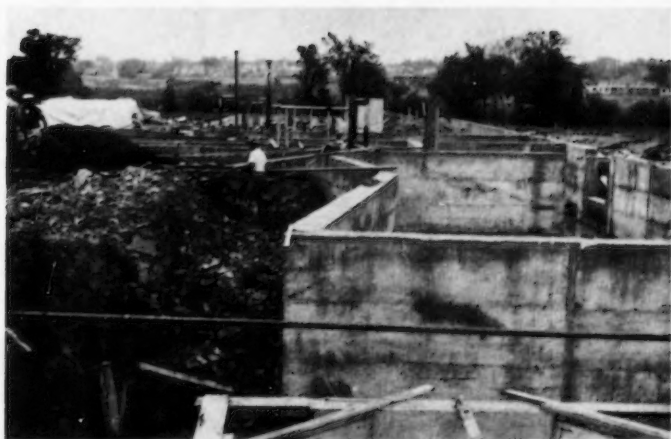
Fig. 11. Walls collapsed by water pressure.
